Code: DH-IPC-HDB4231CP-M12

IP VANDALPROOF CAMERA **DH-IPC-HDB4231CP-M12** - 1080p 2.8 mm DAHUA

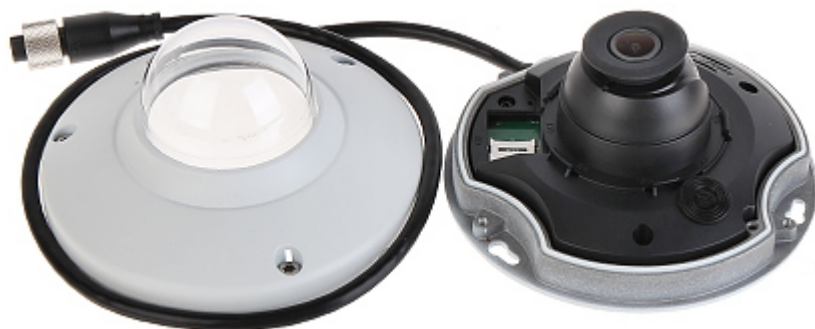
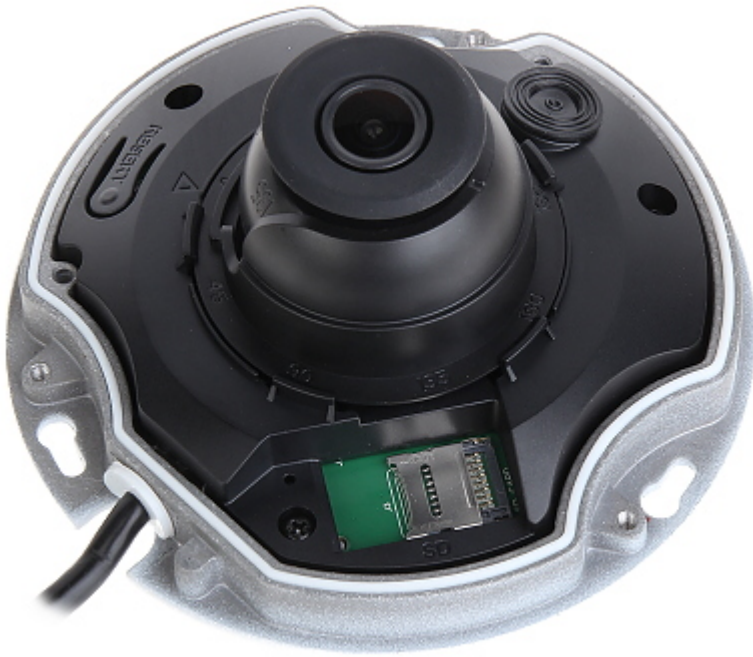
Camera view after remove the Dome cover:

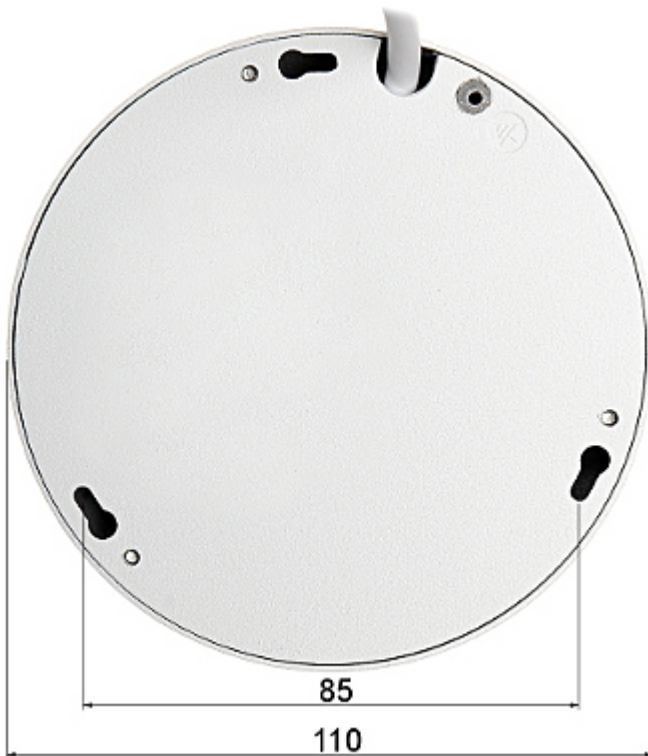
Mounting dimensions:

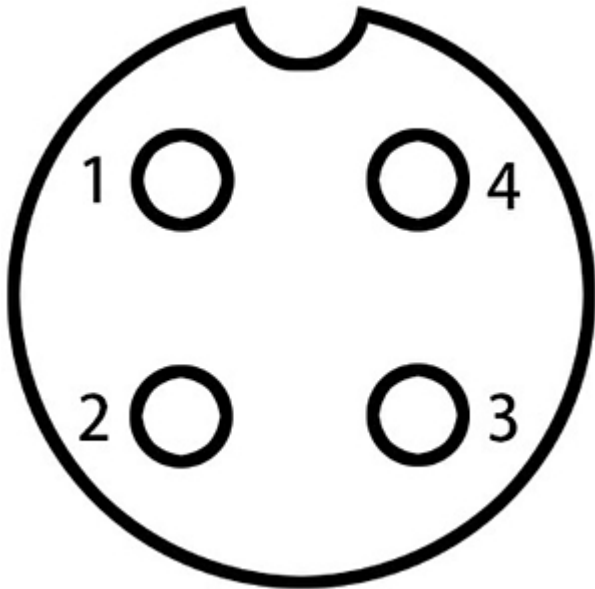
Connectors description:

- 1. Tx+: white/orange
 - 2. Rx+: white/green
 - 3. Tx-: orange
 - 4. Rx-: green
- (according to TIA/EIA568B standard)
In the kit:

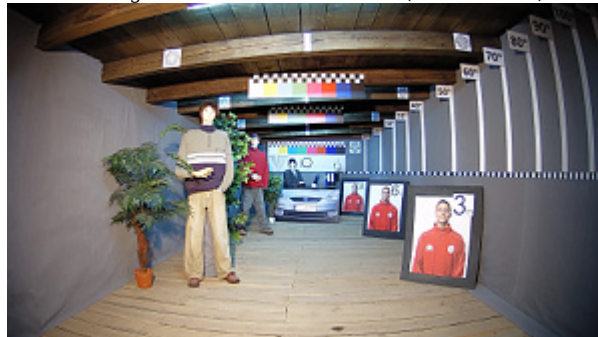
Camera image at artificial illumination (about 30Lux):

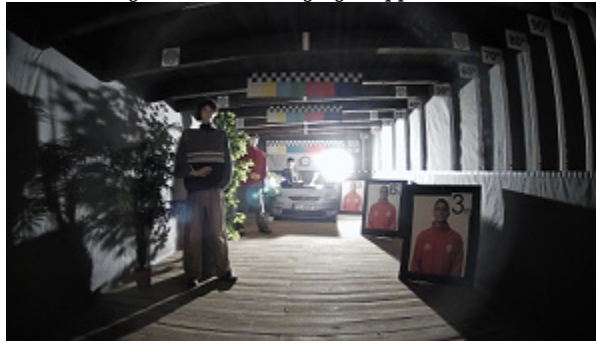
Camera image at direct strong light opposite to camera:
