Code: IPC-HDBW4831E-ASE-0400B IP VANDALPROOF CAMERA **IPC-HDBW4831E-ASE-0400B** - 8.3 Mpx 4 mm DAHUA

IP camera with efficient H.264/H.265/MJPEG image compression algorithm for clear and smooth video streaming at maximal resolution of $3840 \times 2160 \ (8.3 \ \text{MPx})$. PoE powering possibility, compatible with the 802.3af standard makes the device more universal and easier to install. The device is equipped with ePoE technology which enables transmission up to $800 \ \text{m}$ at a speed of $10 \ \text{Mb/s}$ or $300 \ \text{m}$ at a speed of $100 \ \text{Mb/s}$ via cat. $5e \ \text{twisted-pair}$. Camera is according to IP67 Index of Protection norm.

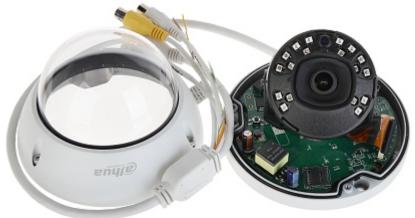
Camera view after remove the Dome cover:

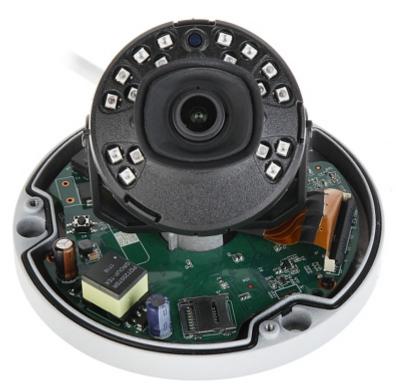
Micro SD card slot is located inside the camera:

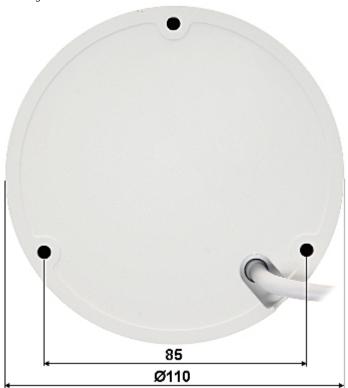
Mounting side view:

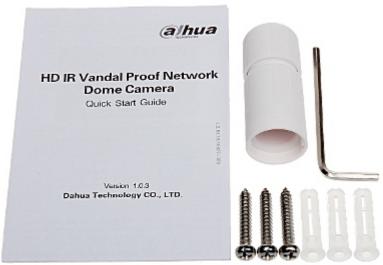
In the kit:

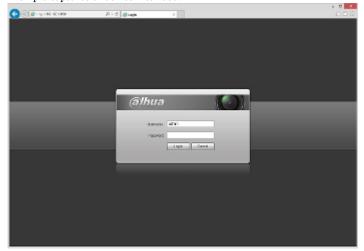
Example captures of device interface:
