Code: HAC-HDBW2221F-0280B

## HD-CVI, PAL VANDALPROOF CAMERA **HAC-HDBW2221F-0280B** - 1080p 2.8 mm DAHUA

# DATA SHEET

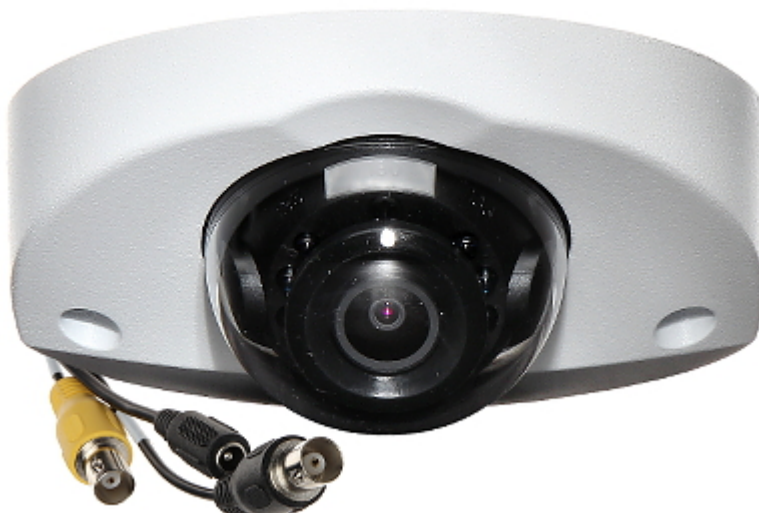
Megapixel camera with 1/2.7" CMOS sensor and HD-CVI (High Definition Composite Video Interface) / PAL. The HD-CVI interface allows to transmission of analog, composite video signal via coaxial cable. It enables the transmission of HD resolution images for even 500 m distance with keeping the low costs of the installation. During transmission there are no delays and is maintained the original, high quality image. The camera has a very flat profile, it's only 51 mm out from the ceiling.
