Code: IPC-HDBW4431F-M12-0280B

## IP VANDALPROOF CAMERA **IPC-HDBW4431F-M12-0280B** - 4 Mpx 2.8 mm DAHUA

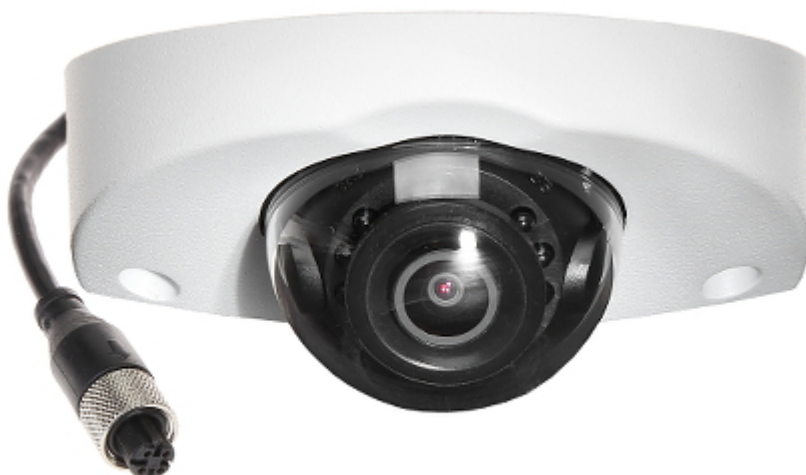
IP camera with efficient H.264 / H.265 image compression algorithm for clear and smooth video streaming at maximal resolution of 2688 x 1520 (4.0 MPx).

PoE powering possibility, compatible with the 802.3af standard makes the device more universal and easier to install.

The camera has a very flat profile, it's only 51 mm out from the ceiling.

**Attention!** M12 connector.
