Code: IPC-HDB4231C-M12-0280B
IP VANDALPROOF CAMERA **IPC-HDB4231C-M12-0280B** - 1080p 2.8 mm DAHUA

IP camera with efficient H.264 / H.265 image compression algorithm for clear and smooth video streaming at maximal resolution of 1920 x 1080 (1080p).

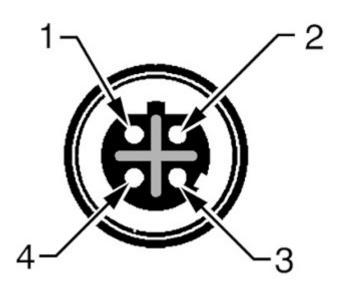
Connectors description:

Tx+: white/orange
 Rx+: white/green
 Tx-: orange

4. Rx-: green

(according to TIA/EIA568B standard)
