Code: IPC-HDBW4431E-ASE-0280B
IP VANDALPROOF CAMERA IPC-HDBW4431E-ASE-0280B - 4.0 Mpx, 2.8 mm DAHUA

IP camera with efficient H.264/H.265/MJPEG image compression algorithm for clear and smooth video streaming at maximal resolution of $3840 \times 2160 \ (8.3 \ \text{MPx})$. PoE powering possibility, compatible with the 802.3af standard makes the device more universal and easier to install. The device is equipped with ePoE technology which enables transmission up to $800 \ \text{m}$ at a speed of $10 \ \text{Mb/s}$ or $300 \ \text{m}$ at a speed of $100 \ \text{Mb/s}$ via cat. $5e \ \text{twisted-pair}$. Camera is according to IP67 Index of Protection norm.

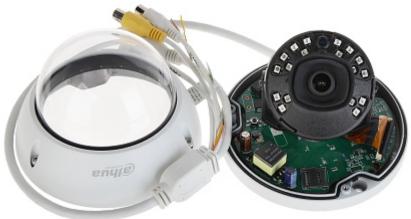
Camera view after remove the Dome cover:

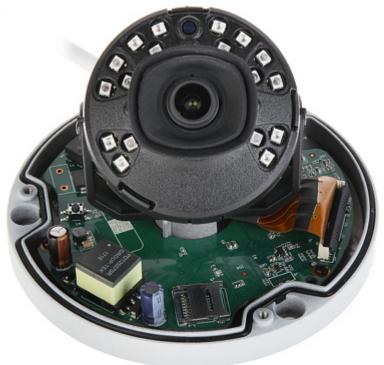
Micro SD card slot is located inside the camera:

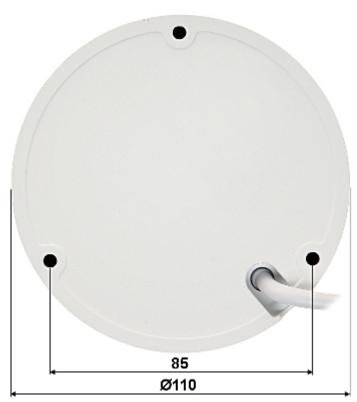
Mounting side view:

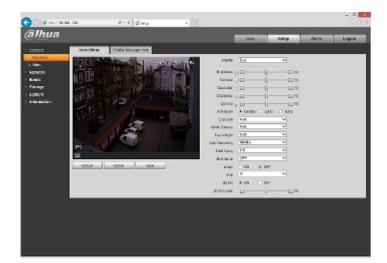
Example captures of device interface:
